LANDSLIDES AND RELATED FEATURES  
Interpreted  
from aerial photographs:

LANDSLIDES AND RELATED FEATURES

OF THE NORMANDY, TENN. QUADRANGLE

U.S. Geological Survey  
Open File Map 82-750 (D-14)

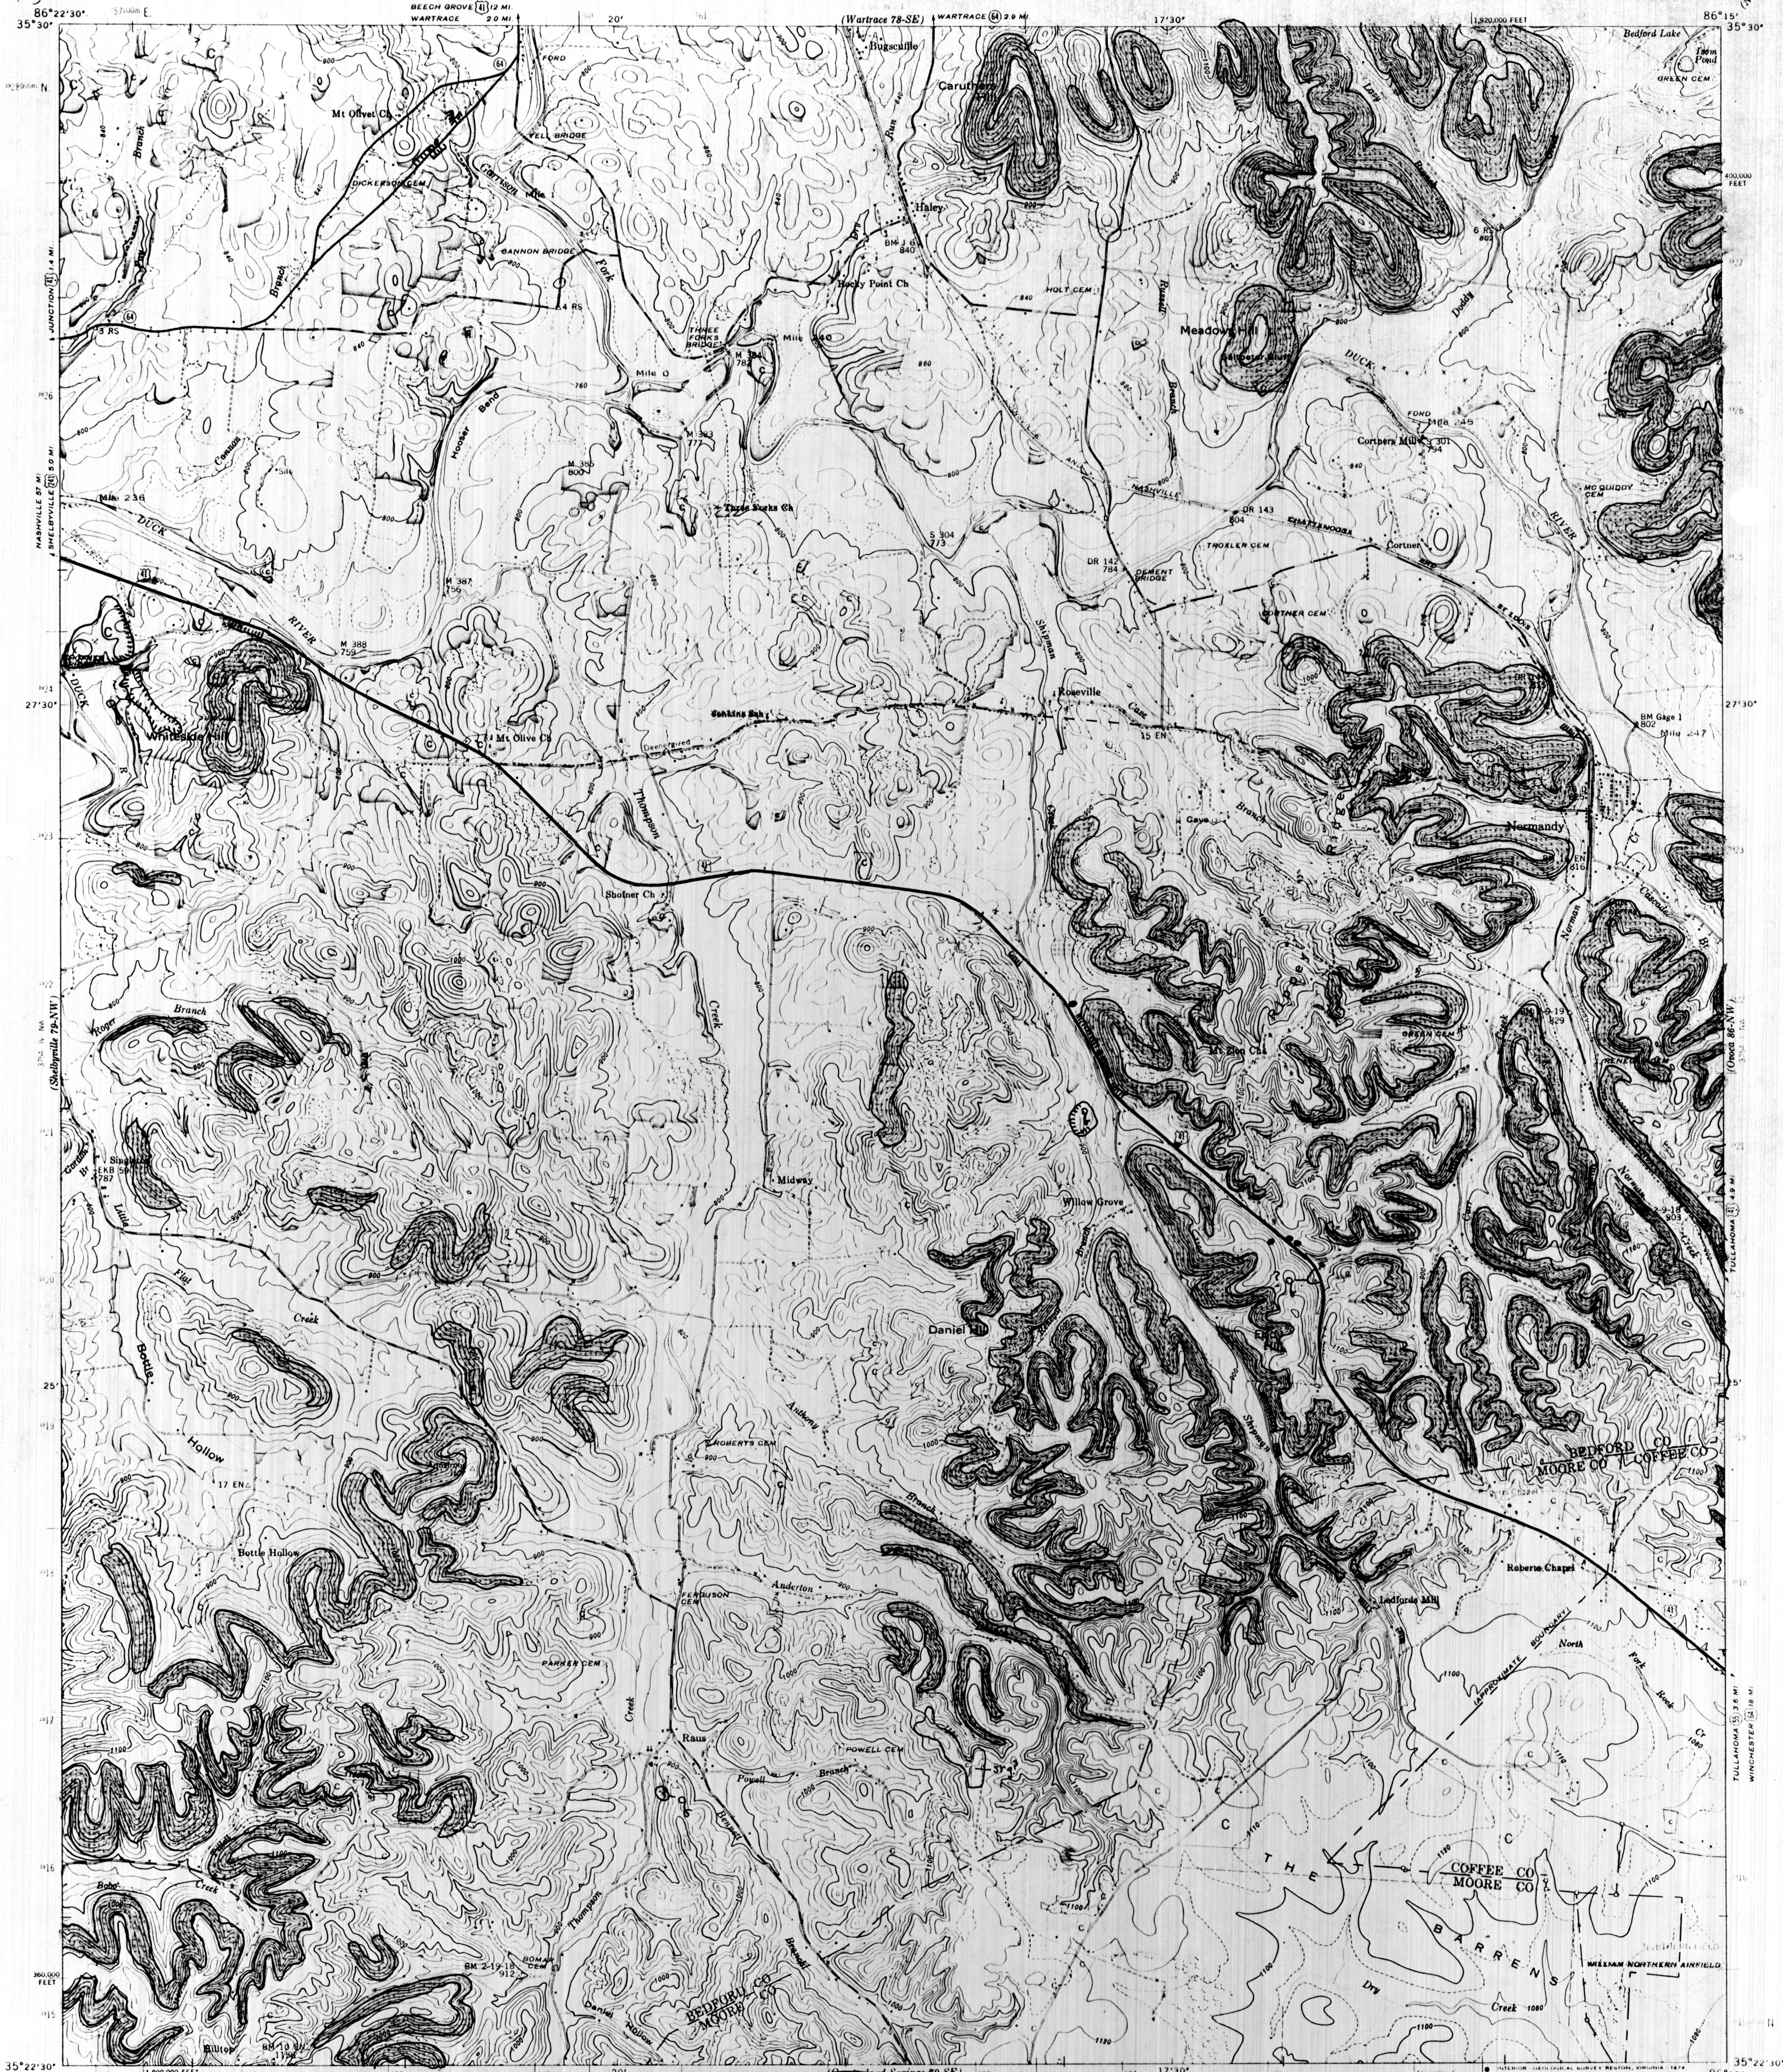
**ACTIVE OR RECENTLY ACTIVE LANDSLIDE**  
Complex landslide composed of earthflow, debris  
slide, earth and rock slump. Identified from  
historical records, and from scars, debris and  
other field evidence. Ground extremely unstable;  
sliding accelerated by excavation, loading and  
changes in drainage conditions. May include  
areas with several active slides too small to  
be shown separately. Questioned where doubtful.

**OLD LANDSLIDE**  
Area of extensive hummocky ground caused by  
earthflow and earth and rock slump. Lacks  
clear evidence of active sliding. Relatively  
stable in natural, undisturbed state,  
generally not affected by small structures properly  
sited in areas away from the edge of the toe;  
can be reactivated by extensive, rapid exca-  
vation, loading, and changes in ground water and  
surface water conditions. Area of old landslide  
probably includes recent ones not identified  
from field evidence or otherwise documented.  
Upslope boundary of landslide generally defined  
by modified scarp, but downslope (toe) may be  
gradational and not well defined. Questioned  
where doubtful.

**COMBINATION LANDSLIDE**  
Area of recent and old slides in which  
individual slides are not identified.

**COLLUVIAL SLOPE**  
Valley wall along major streams with slope as  
steep as 40° (85%); stony, clayey silt soil up  
to 50 ft. (15 m) thick; commonly buttressed by  
a terrace or bench at the toe of the slope; very  
susceptible to sliding by cutting of toe area,  
removal of terrace or bench, and overloading;  
slide commonly activated without apparent cause.

**COLLUVIAL SLOPES WITH LANDSLIDES**  
Landslides too small or obscure to map  
individually.

**AREAS SUSCEPTIBLE TO DEBRIS FLOWS AND DEBRIS  
AVALANCHES**  
Primarily shallow, narrow ravines and chutes with  
accumulation of stony colluvium generally 10 ft.  
(3 m) or less in thickness; susceptible to rapid  
movement during intense rainfall. Most ravines  
and chutes designated show evidence of former  
debris flows and avalanches.

**AREAS SUSCEPTIBLE TO ROCKFALL**  
Steep, locally vertical, natural and man-made  
slopes and cliffs, 15 ft. (4.5 m) or more high;  
formed dominantly of sandstone, limestone, sandy  
shale, mudstone and claystone. Interbedded mud-  
stone, claystone and shale weather rapidly leaving  
sandstone and limestone rock faces unsupported.

**SOIL AND ROCK SUSCEPTIBLE TO LANDSLIDING**  
Soil and rock similar to that involved in land-  
slides elsewhere in map area; primarily areas  
underlain by claystone, mudstone and shale  
associated with other rock types. Rock weathers  
rapidly on exposure forming clayey soil highly  
susceptible to sliding. Includes coves (U-shaped,  
shallow valleys) containing thick layers of clayey  
soil that are very susceptible to sliding where  
excavation breaks continuity of slope and where  
overloaded by artificial fill.

**AREAS LEAST PRONE TO LANDSLIDES**  
Map areas in which no patterns or symbols are shown;  
primarily valley floors, ridge tops and broad  
benches; modification by excavation and fill may  
lead to local landslides.

**NOTE**  
Information shown is intended as a  
general guide to ground conditions as of  
the date of field check. Additional  
landslides and rockfalls should be anticipated  
in all map units. The map unit depicts  
the dominant condition in the area delineated  
and variations in slope stability may occur  
at any point in the unit. This map is suit-  
able for general planning purposes and as a  
supplement to more detailed studies for site  
selection. The map cannot be used as a sub-  
stitute for detailed geologic and engineering  
investigations to establish design and  
construction criteria of specific sites.  
Some symbols may not appear on this map  
because the description is applicable to a  
series of maps.

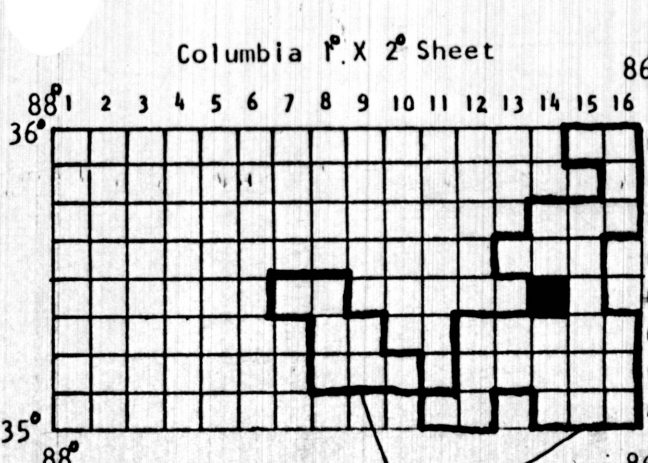
The first five digits of the open file number designate the  
specific 1:250,000 scale map sheet of which this quadrangle  
is a part. The last two digits designate the position of the  
quadrangle in a subdivision of the 1:250,000 scale map based  
on rows and tiers shown in the diagram to the right. The  
location of this quadrangle is shown by the black square.
